ASBESTOS MANAGEMENT SURVEY REPORT

HOME FROM HOME

Fairhaven, 99 Bath Road, Old Town, Swindon, SN1 4AX

91771-237370

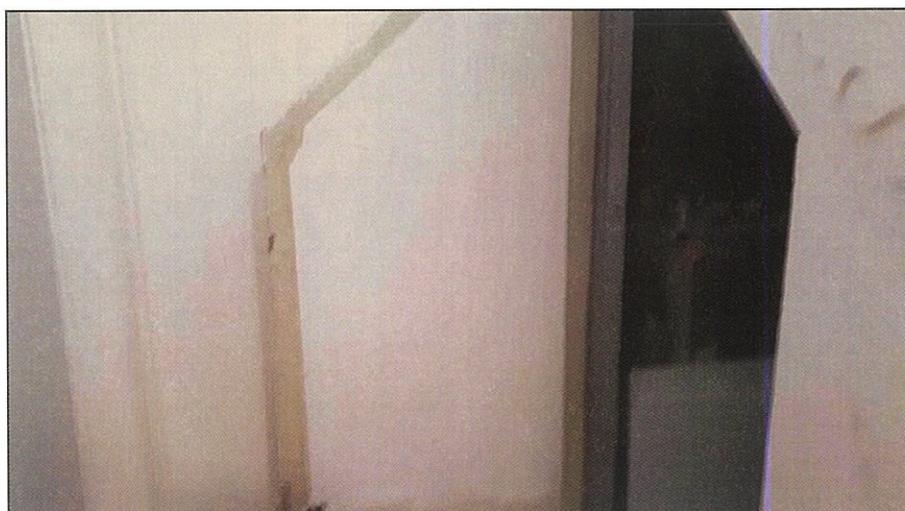
| Building: | . | Material Description: | Insulation board panel to door |

Material Risk: N/A
Asbestos Type: 0 - No asbestos detected

Recommendation: No further action required

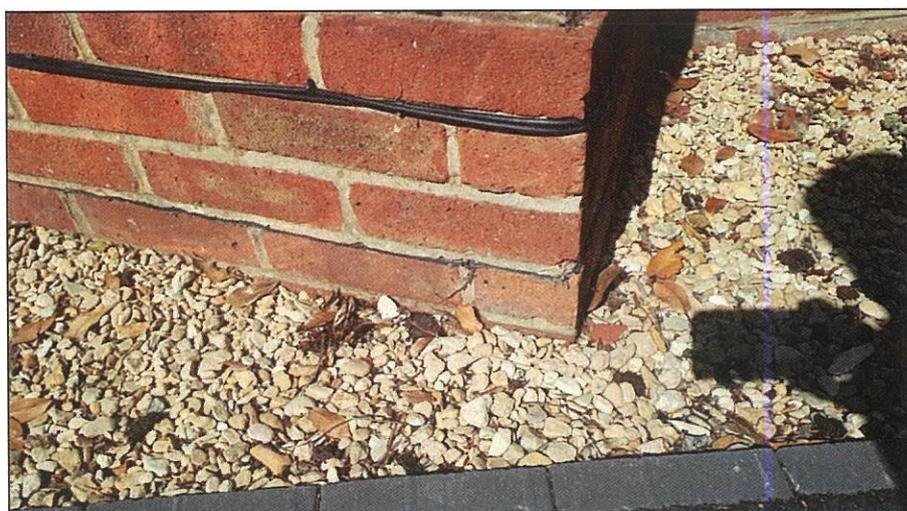
| Building: | . | Material Description: | Damp proof course |

Material Risk: N/A
Asbestos Type: 0 - No asbestos detected

Timescale for Recommendation : No action
Recommendation: No further action required

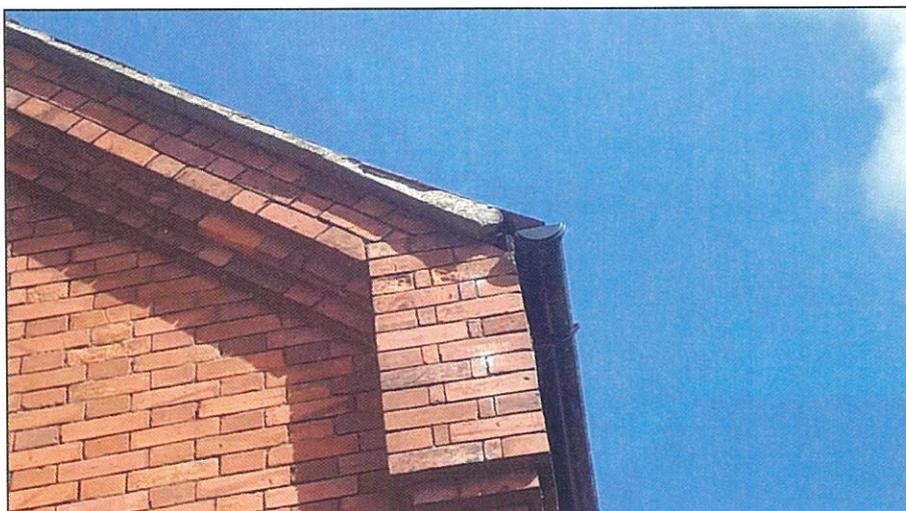
| Building: | . | Material Description: | Cement verge undercloaking |

| Material Risk: | 3 |
| Asbestos Type: | 1 - Chrysotile |
| Extent of Damage: | 0 - Good |

Comments: Presumption Reason: too high to access

Timescale for Recommendation : 12 months

Recommendation: Manage
