# COMBINED FIRE AND HEALTH & SAFETY RISK ASSESSMENT.

| Address of premises: | 99 Bath Road,<br>Swindon,<br>SN1 4AX |
| Date of fire risk assessment: | 15 <sup>th</sup> May 2025 |

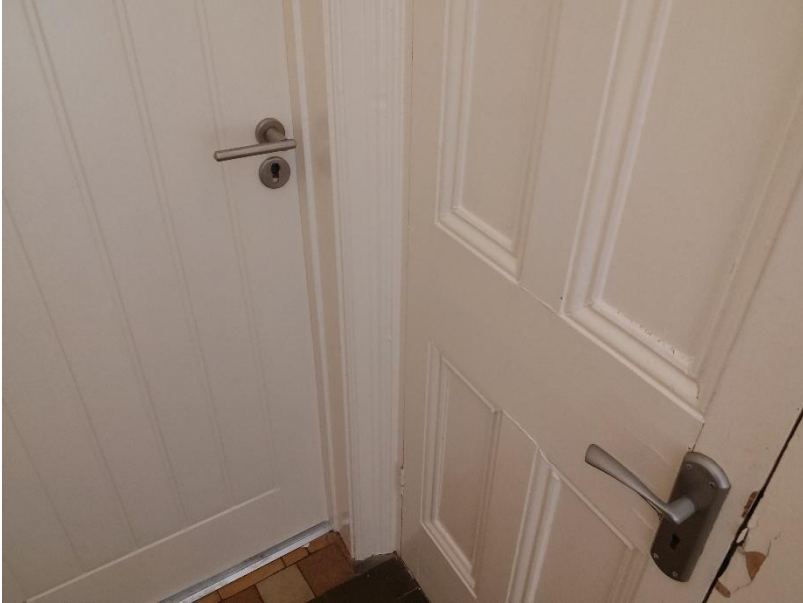
| <p>03</p> | <p>It was noted during this fire risk assessment that the understairs cupboard and adjacent door within block 1-3 had non-FB locks fitted which meant these doors could not be inspected during this assessment. It is recommended that these locks are changed in order to facilitate future inspection.</p> <p>Furthermore, it is essential that each door communicating with the means of escape is a suitable fire door, providing a minimum of thirty minutes fire resistance, hung on three grade 13 hinges, combine cold smoke and intumescent seal, "Fire Door Keep Locked" or "Fire Door Keep Shut" signage where appropriate along with having a functioning self-closing device fitted that positively closes the door flush to the frame if a lobby door. It is recommended therefore that the RP instruct a suitably qualified and competent contractor to conduct a fire door inspection to all communal area doors providing advice on suitability. Any shortcomings identified by this inspection should be addressed as a priority by upgrading or replacing the door.</p> <p>Flat entrance doors, communal area doors, the seals and the self-closing devices should then be subjected to an annual inspection and maintenance schedule.</p> | <p>2</p> | <p>B</p> | <p>Action complete</p> <p>Inspection scheduled in accordance with current legislation</p> |

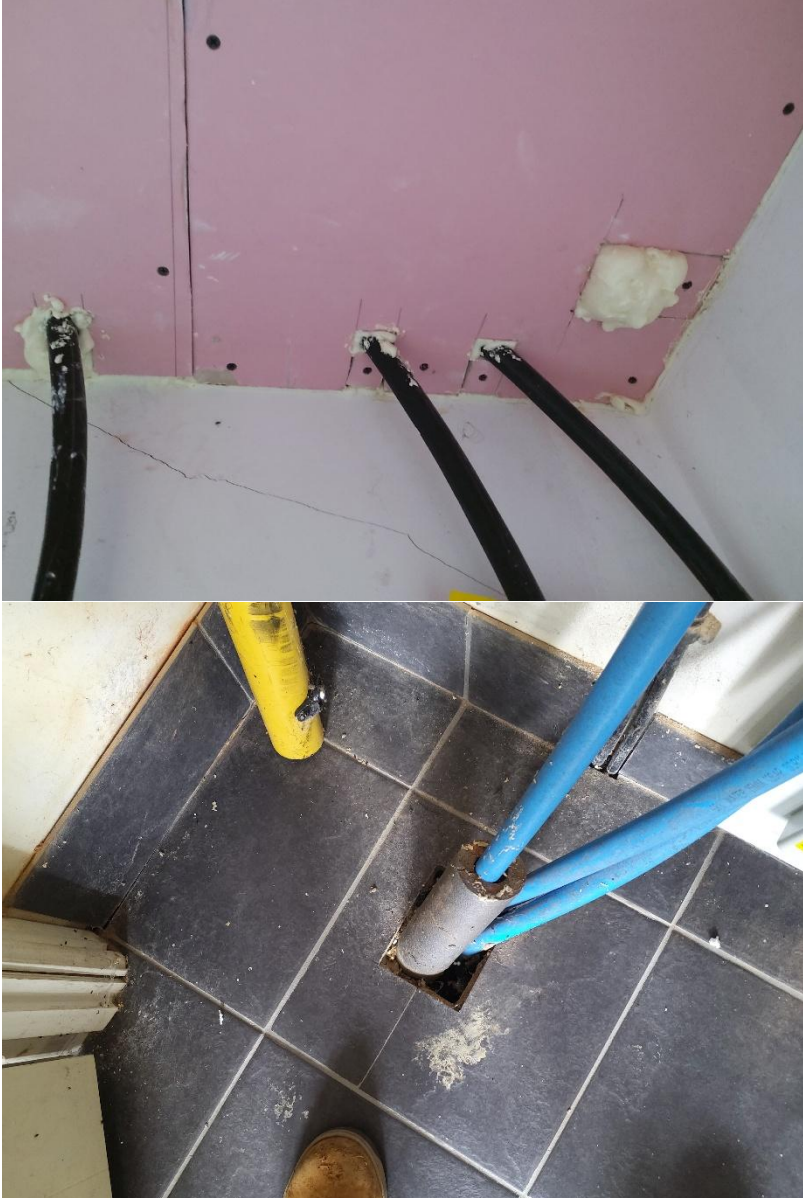
| <p>06</p> | <p>It was noted during this fire risk assessment that there were deficiencies in the compartmentation in the following areas:</p> <ul style="list-style-type: none"> <li>• Large breach in the floor of the electrical intake cupboard in block 1-3 and in the back of the electrical intake cupboard in block 5-8 that could allow smoke and fire to spread undetected throughout the premises.</li> <li>• Overuse of foam within the electrical intake cupboard of block 1-3. Fire resistant foam should be used as a sealant only as the changes in viscosity cannot guarantee the 30 minutes fire protection for the repair of large breaches.</li> </ul> <p>It is therefore recommended that the RP instructs a suitably qualified and competent contractor to repair the breaches along with replacing the overuse of foam with a suitable compound capable of providing a minimum of 30 minutes fire resistance in order to minimise the likelihood of fire spread and to protect the means of escape.</p> | <p>1</p> | <p>B</p> <p>Action required</p> <p>Quotation to be obtained for remedial as required</p> |

| <p>It was noted during this fire risk assessment that there were deficiencies in the compartmentation in the following areas:</p> <ul style="list-style-type: none"><li>Large breach in the floor of the electrical intake cupboard in block 1-3 and in the back of the electrical intake cupboard in block 5-8 that could allow smoke and fire to spread undetected throughout the premises.</li><li>Overuse of foam within the electrical intake cupboard of block 1-3. Fire resistant foam should be used as a sealant only as the changes in viscosity cannot guarantee the 30 minutes fire protection for the repair of large breaches.</li></ul> <p>It is therefore recommended that the RP instructs a suitably qualified and competent contractor to repair the breaches along with replacing the overuse of foam with a suitable compound capable of providing a minimum of 30 minutes fire resistance in order to minimise the likelihood of fire spread and to protect the means of escape.</p> | | |
